La restauration de la continuité écologique: la réglementation et les actions de préservation du saumon atlantique aux États-Unis

Casey Clark, Département des ressources marines du Maine
Hadley Couraud, The Nature Conservancy in Maine

Colloque International des Saumon et des Hommes 3
Brioud, France // 20 octobre 2023

Penobscot River Restoration Project

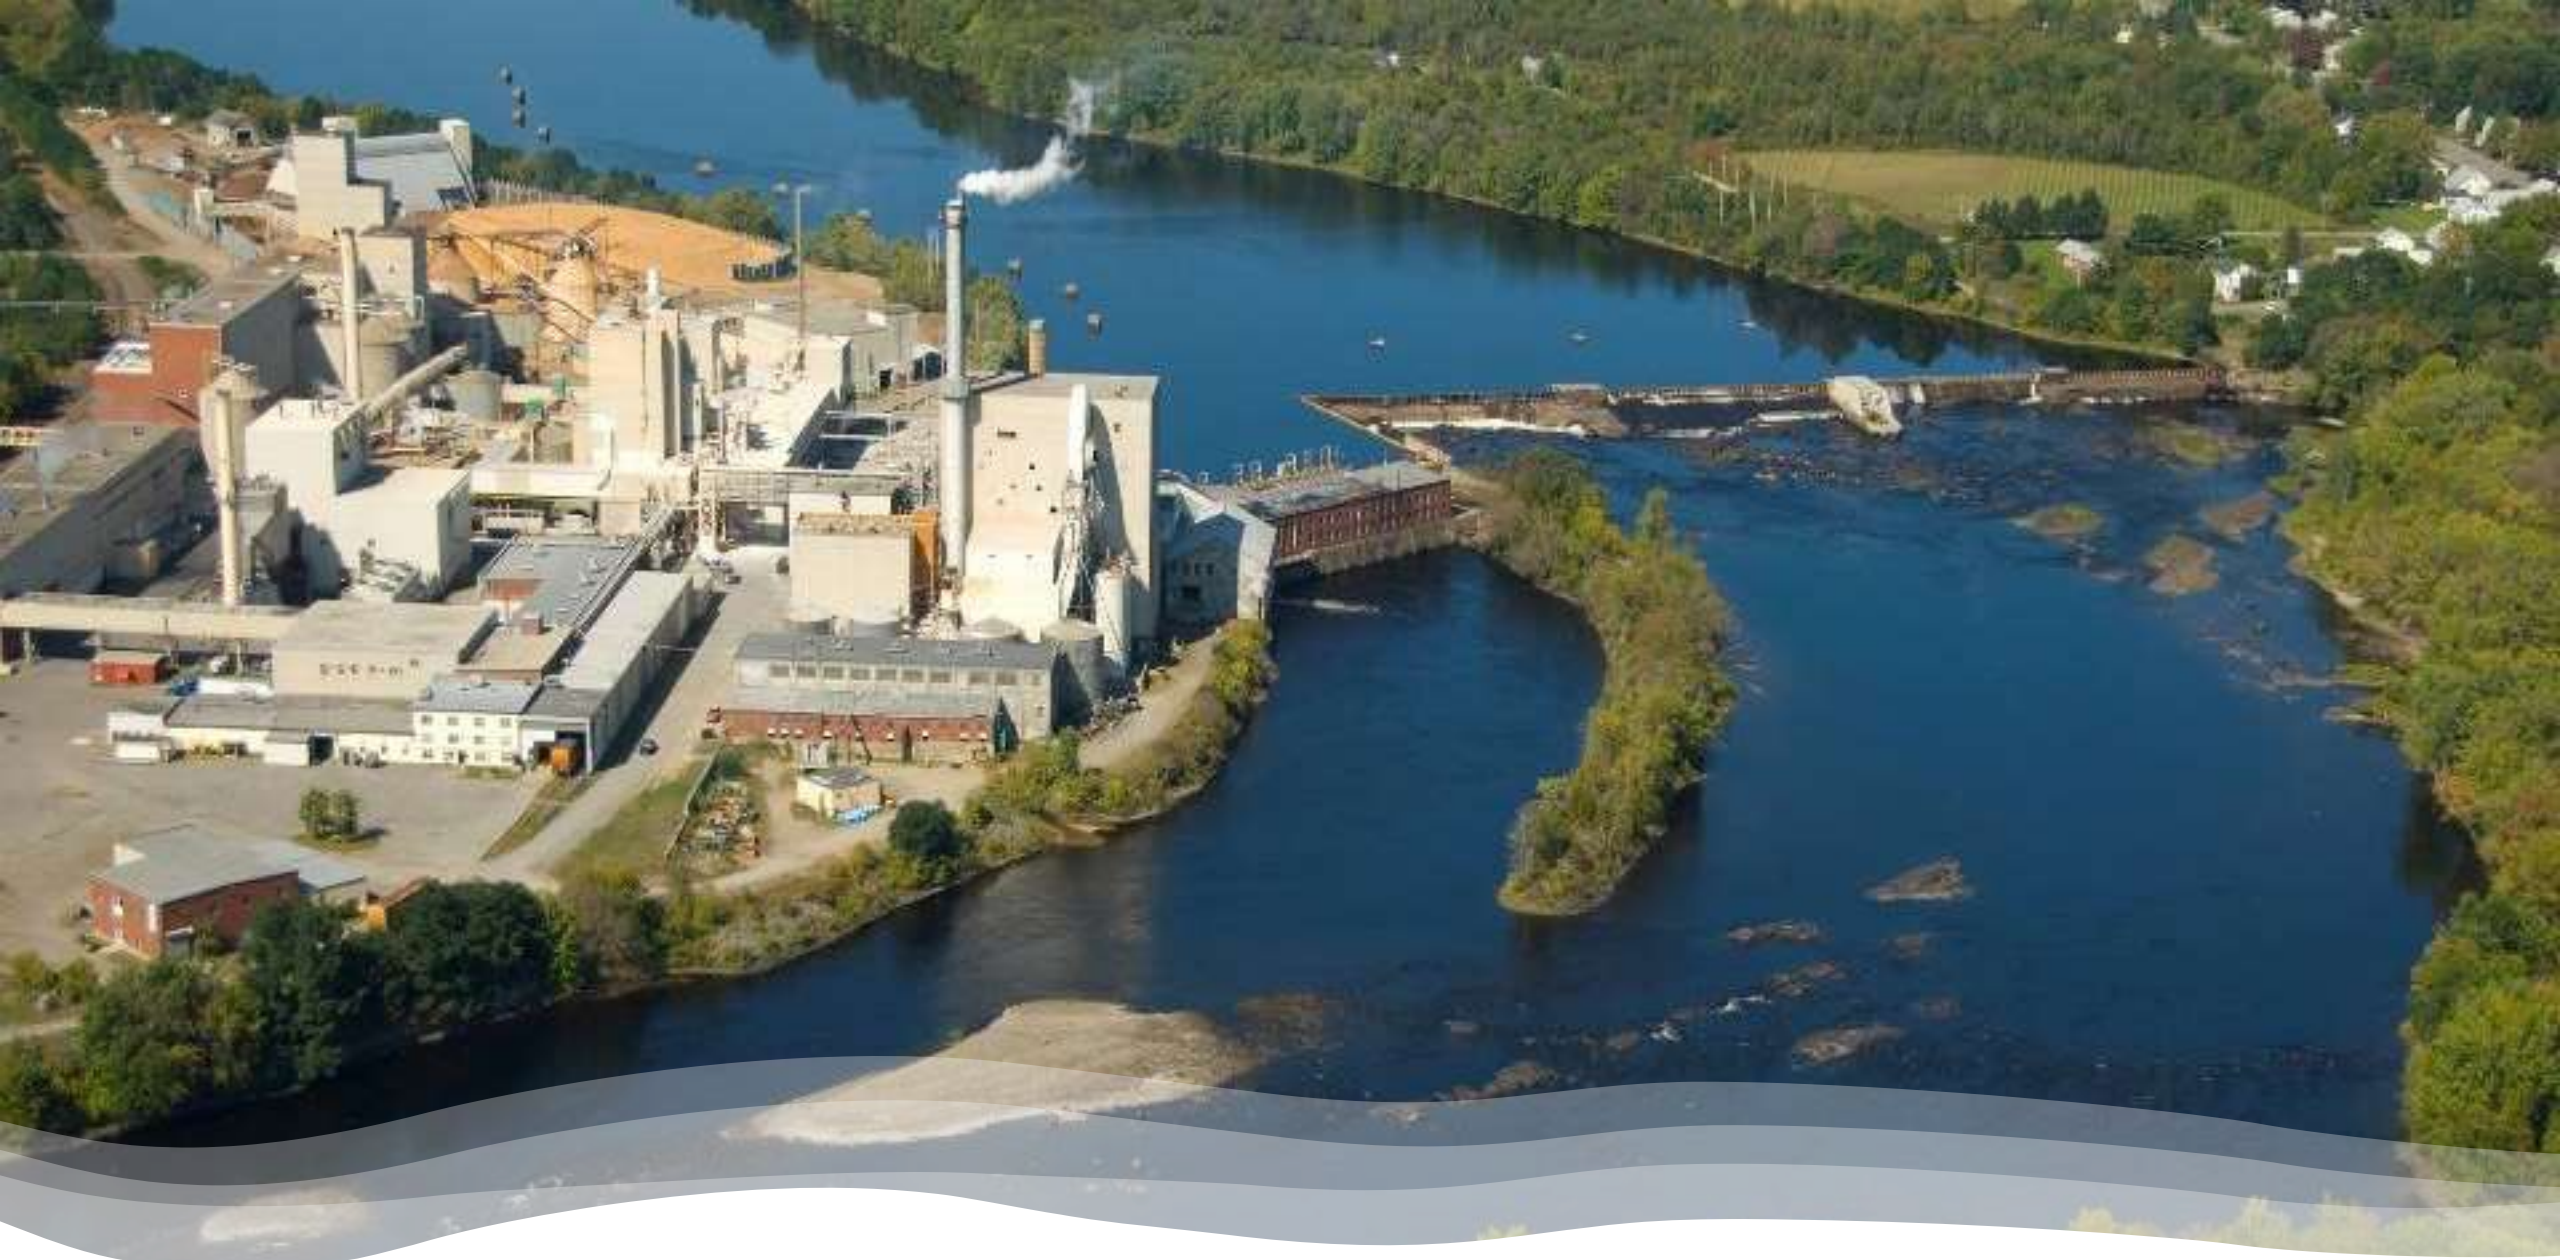
(Former) Great Works Dam

290m wide, 7.3m tall // 2nd Dam up from Ocean (56 kilometers)

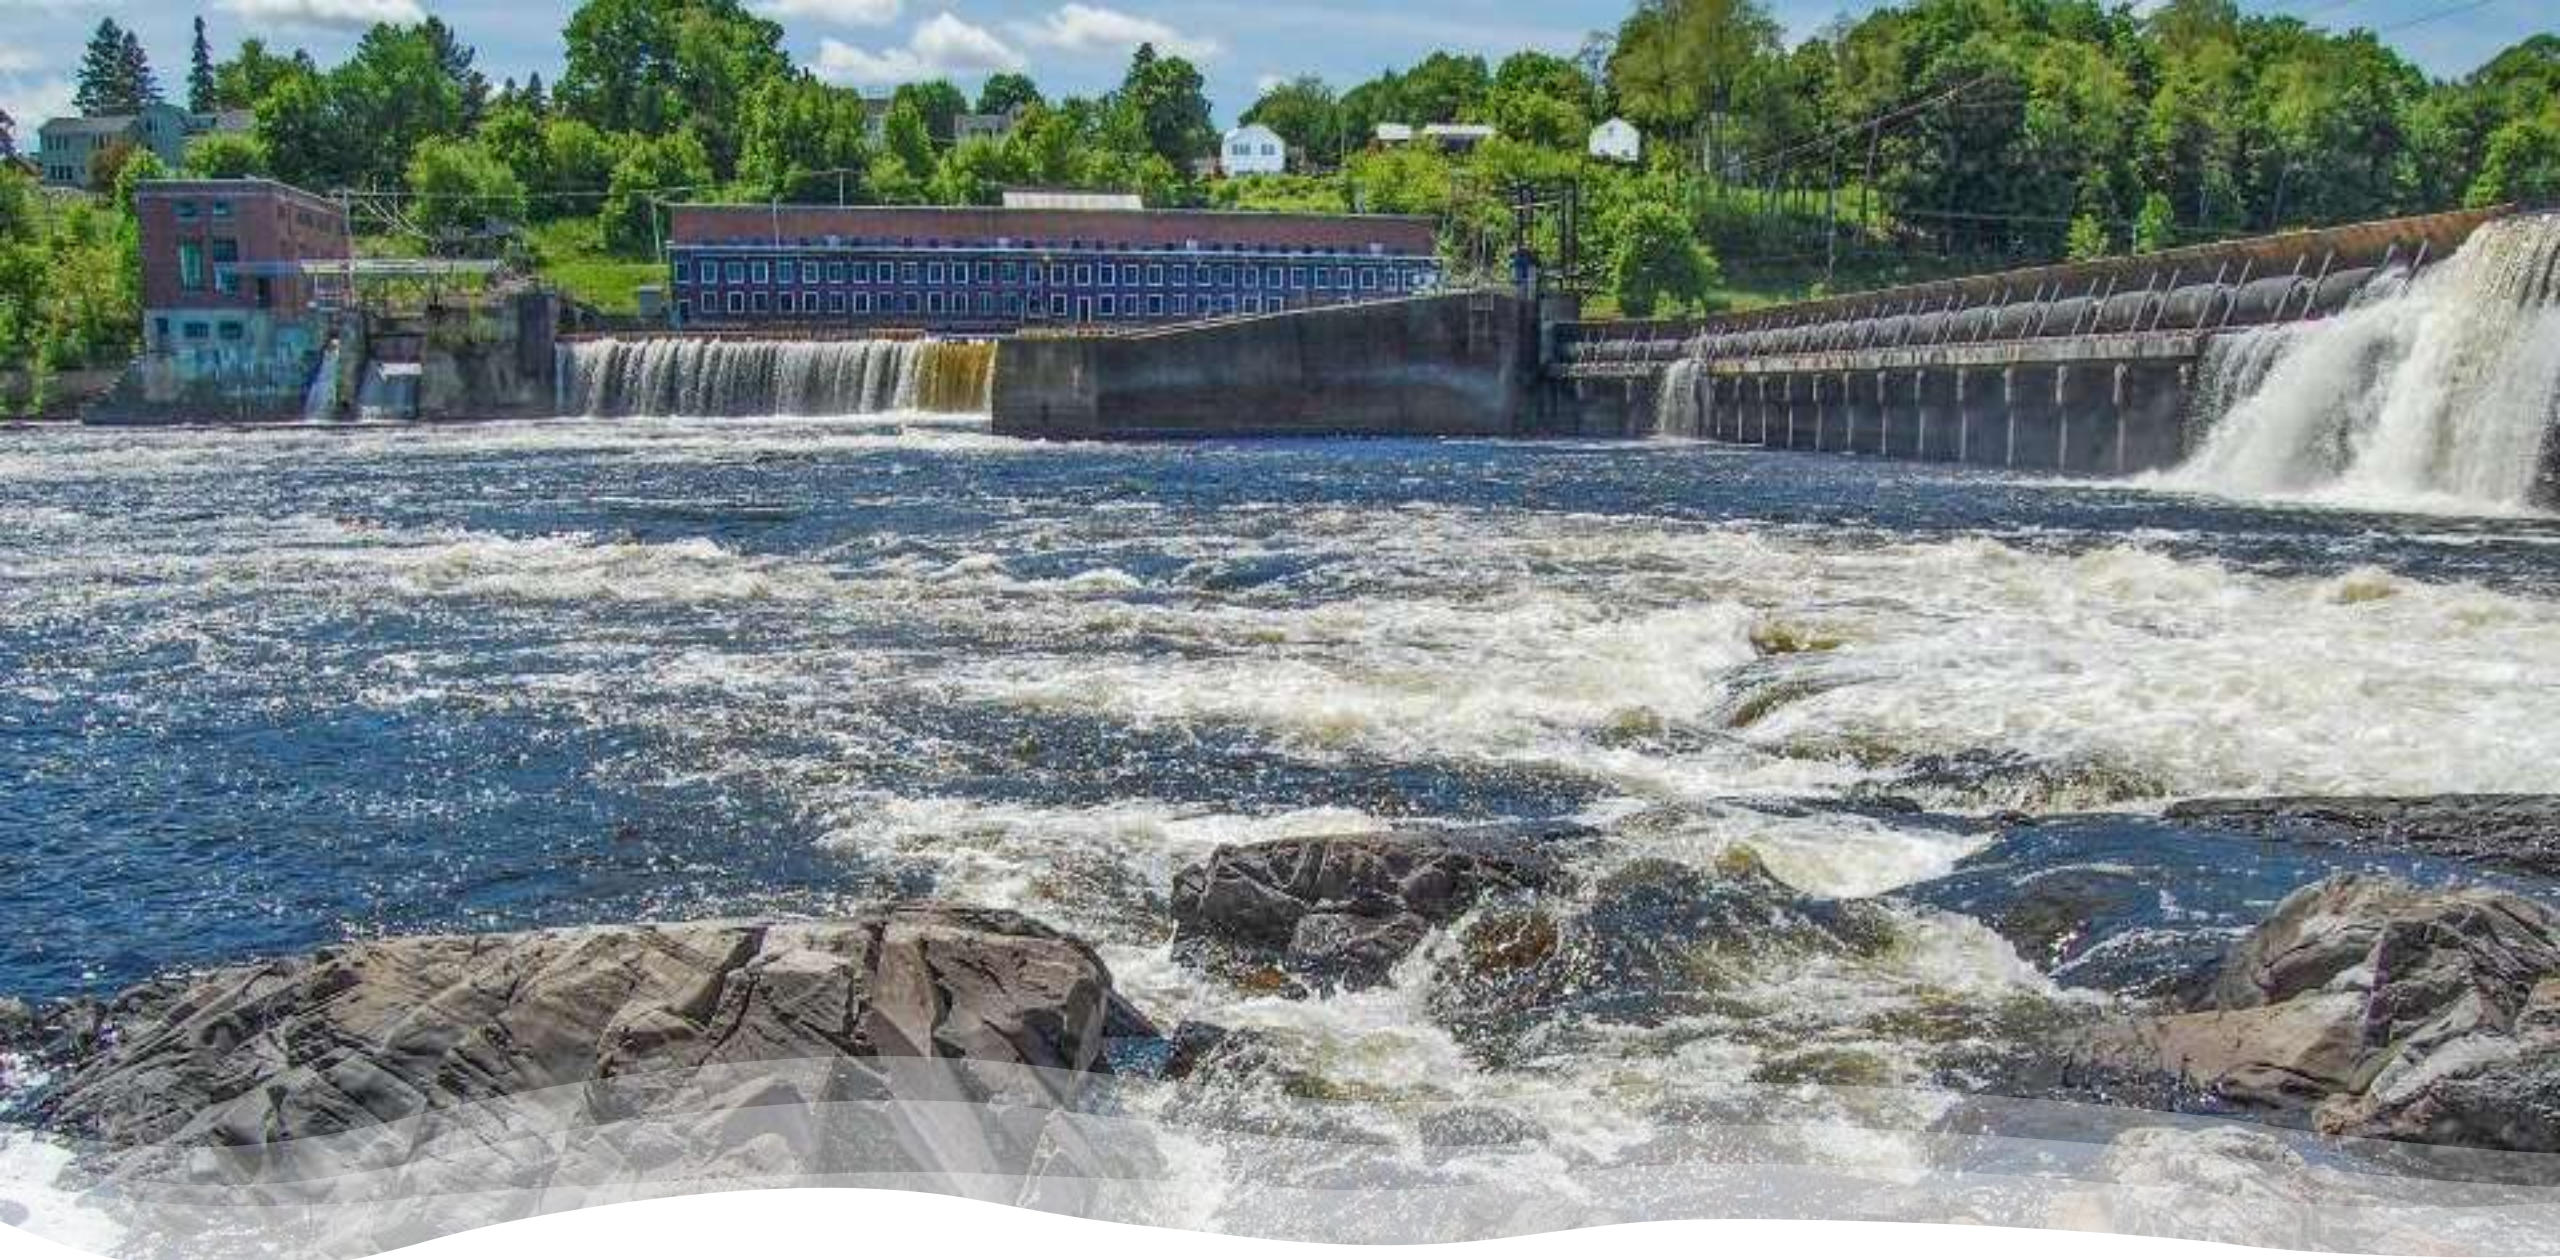
(Former) Veazie Dam

305m wide, 7.3m tall // 1st Dam up from Ocean (48 kilometers)

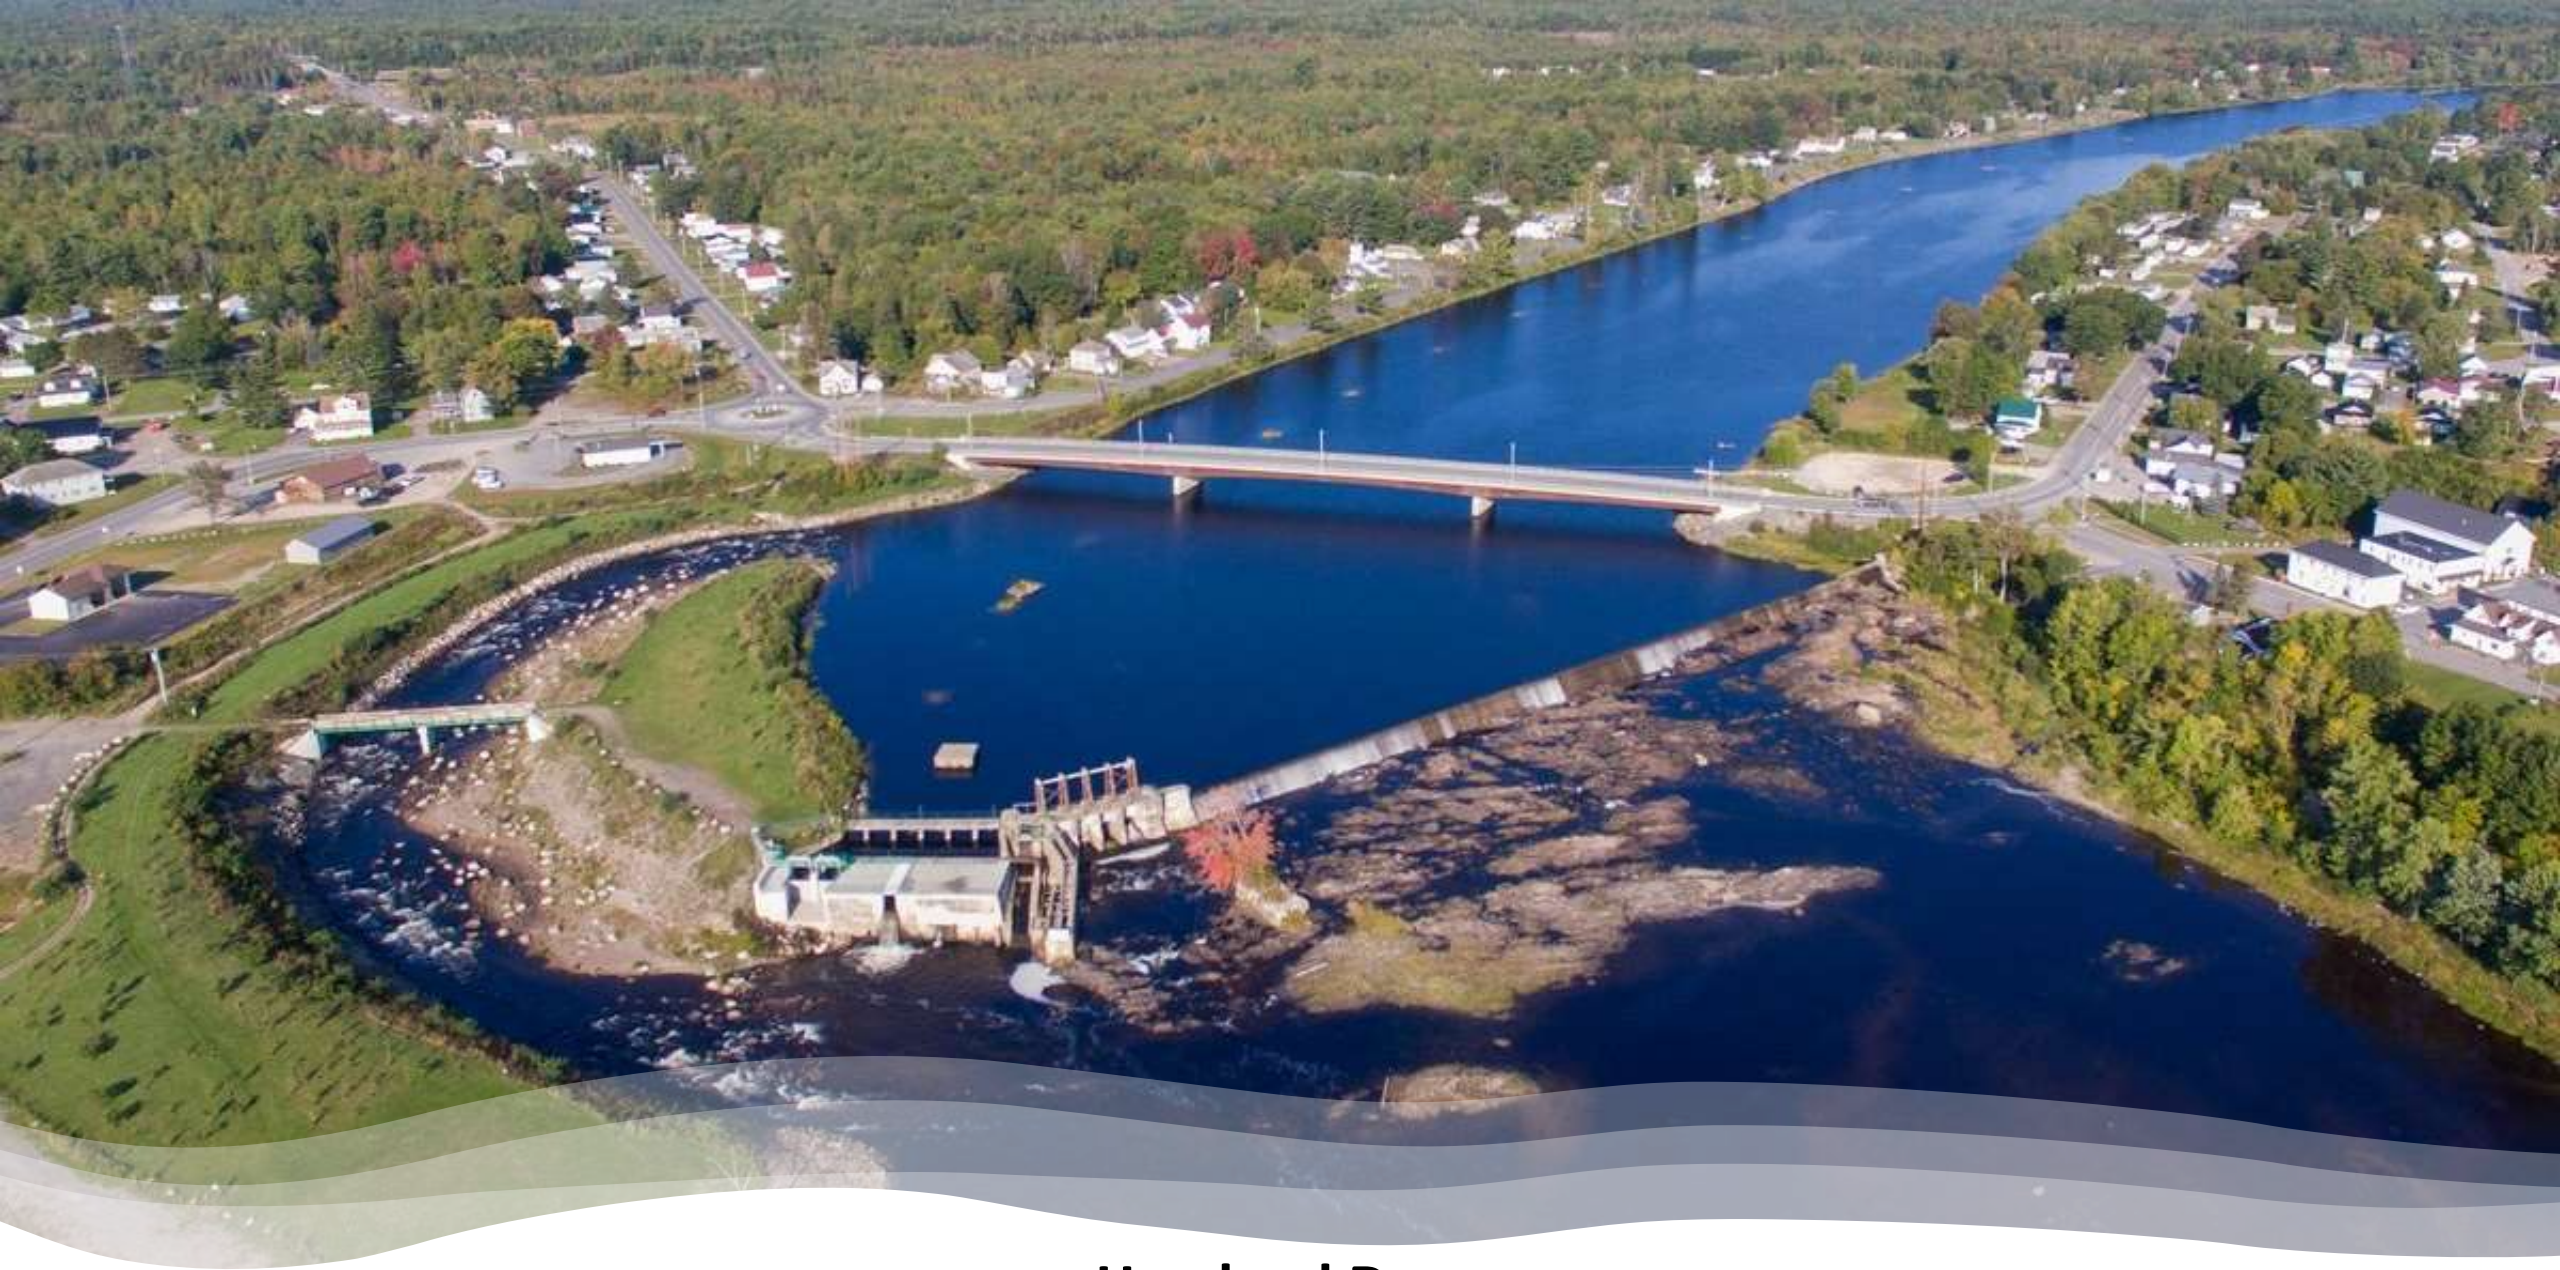
Howland Dam

Decommissioned and nature-life fishway constructed in 2016 (320m long, 33m wide)

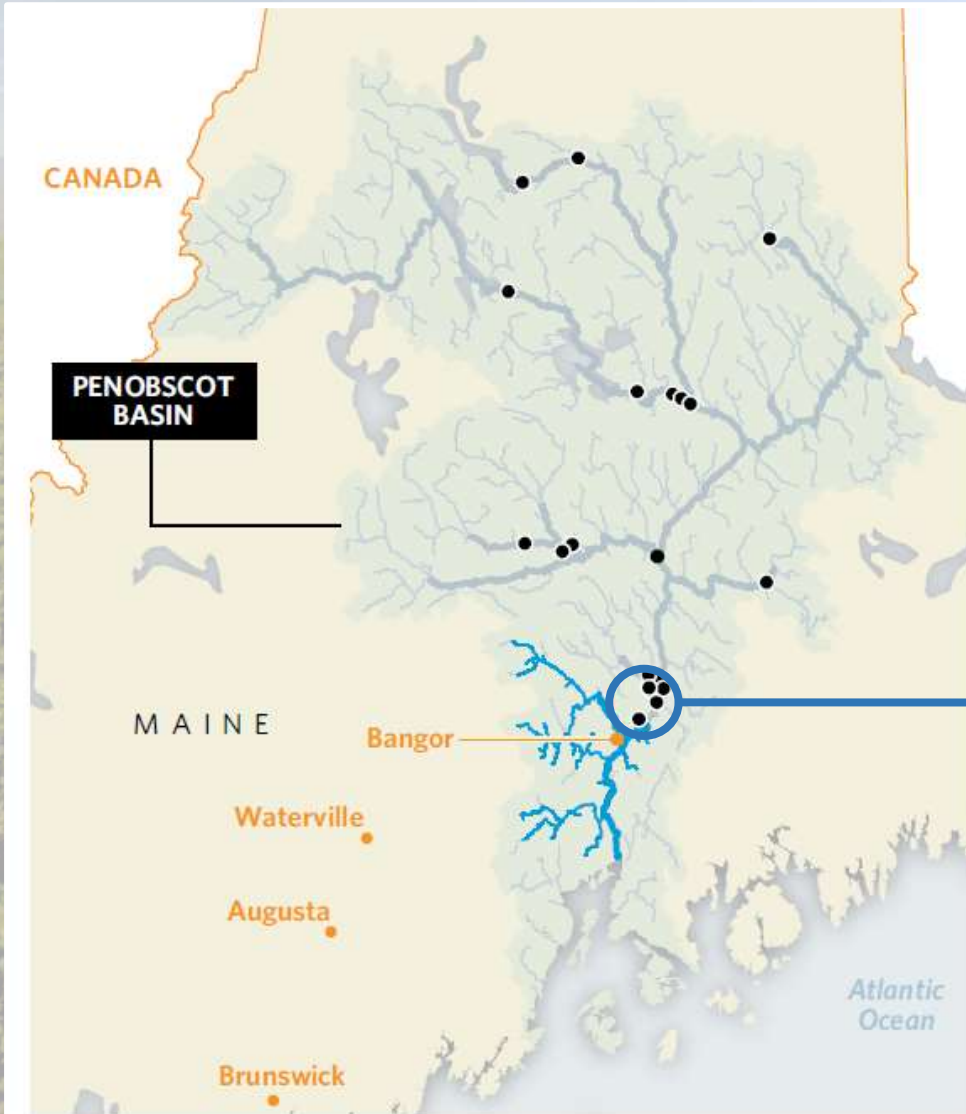
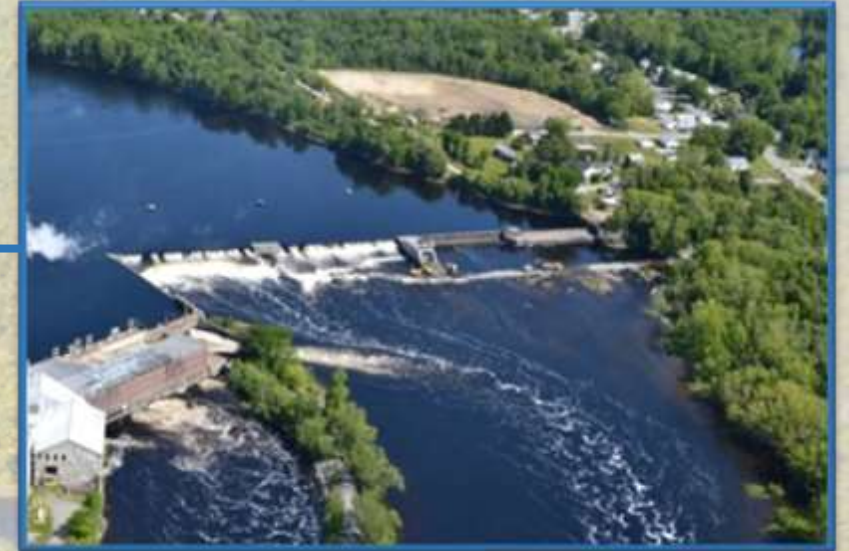
Penobscot River Restoration Begins, June 2012

Largest remaining
run of Atlantic
salmon in the US

● DAMS ON MAINSTREAM
RIVER CHANNELS

— ACCESSIBLE FOR
MIGRATORY FISH

— MAINSTEM
RIVERS

— FULL RIVER
NETWORK

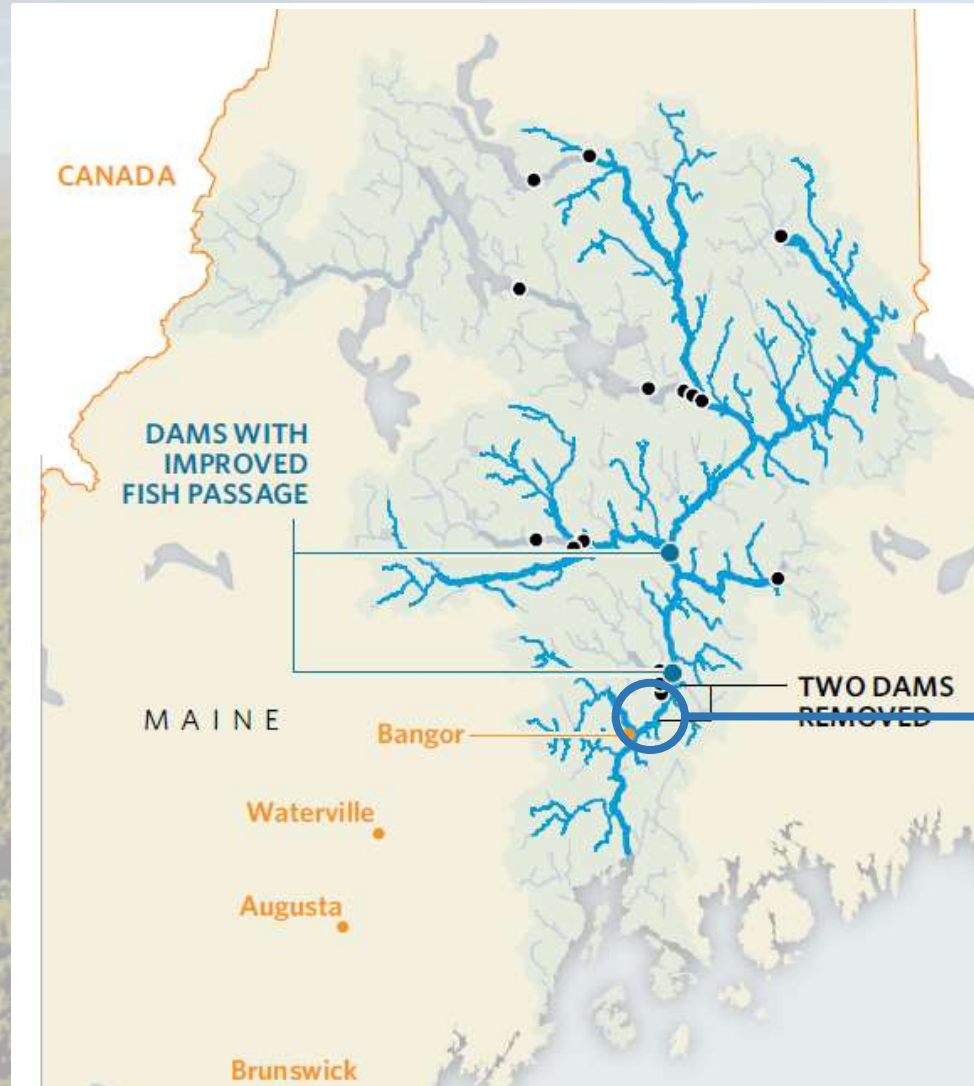
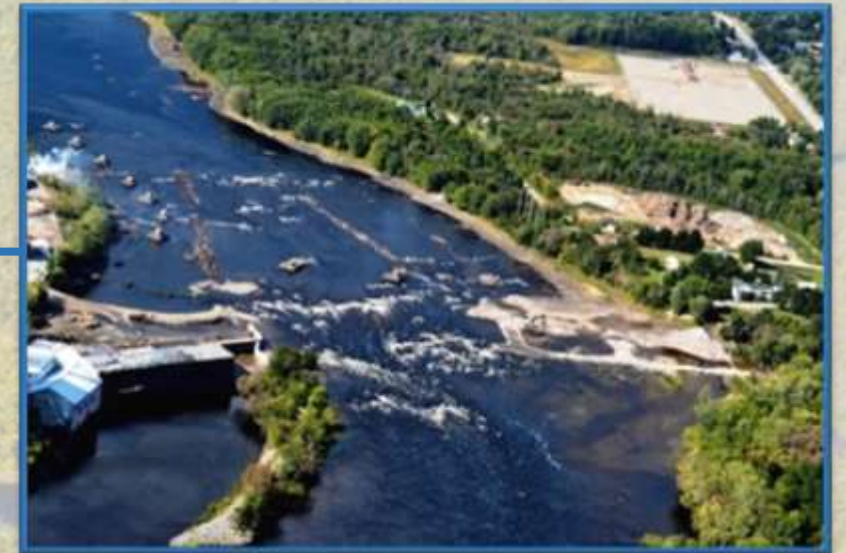
A More Connected Penobscot, May 2016

2,000 mi. of additional
accessible mainstem habitat

● DAMS ON MAINSTREAM
RIVER CHANNELS

— ACCESSIBLE FOR
MIGRATORY FISH

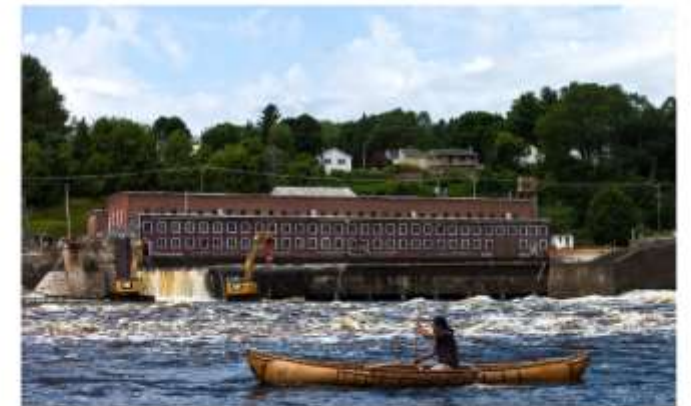
The dismantling of the Veazie Dam will help give 11 species of fish better access to 1,000 miles of spawning habitat. Craig Dilger for The New York Times
